BASTIAN ENGINEERING

M E M O
September 24, 2021

RE: Drain Gallery Report (relates to the ongoing USFS Special Use Permit)

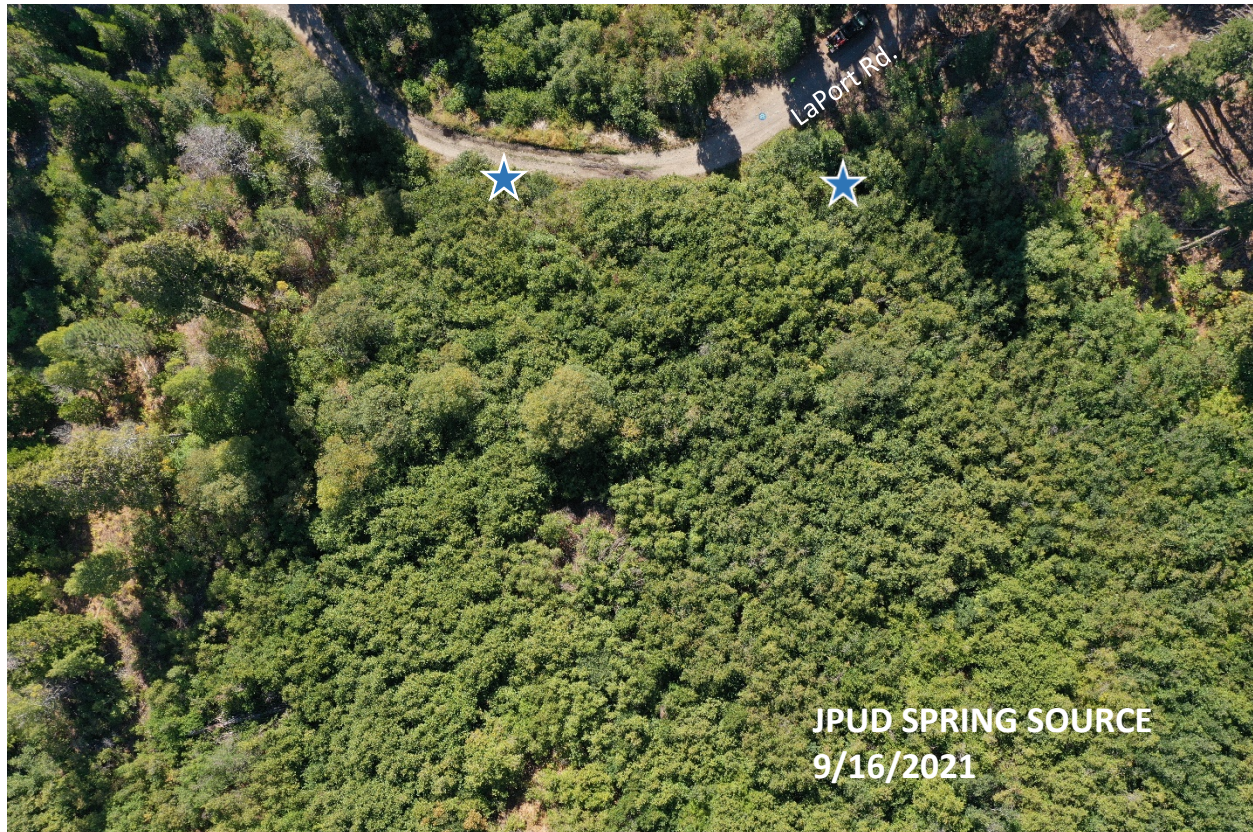
I sent a drone up to take an overhead photograph to see if there might be an

alternate way in. The photo is attached below, and I highlighted the existing diversion structure locations with a star symbol.

There is no apparent access to the drain gallery through the dense vegetation. By way of reference, the Google Earth 1993 historical file image for the same area is shown on the next page. On close inspection, the 1983 drain gallery clearing can be seen, as noted.

The drain gallery is nonfunctioning and should be abandoned in place. The drain's useful purpose no longer exists as the district's water is treated to the current state standards, regardless of whether the source is surface or from the subsurface drain gallery. There is no benefit to JPUD or the USFS to rehabilitate the system.

I recommend that the district approach Evelyn Breedlove of the USFS and indicate that the drain gallery is nonfunctioning, is not needed, and the drain gallery should be excluded from the Special Use Permit.
